# Manhole Inspection Summary

Manhole # S37G\_\_007MH

Insp Date: **8/18/08 3:02 PM**

**Location** Address: **16 s frederick st**

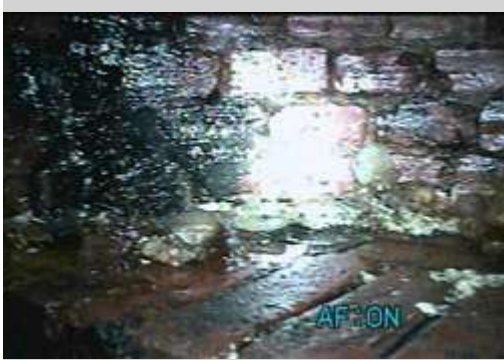
Defect 2

Infiltration: ☐ None ☐ Joint ☐ Cracks ☐ Mortar ☐ Roots ☒ **Wall**

Barrel Infiltration

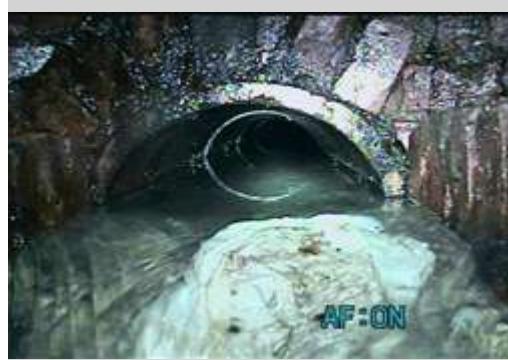
Defect 3

Condition: ☐ Sound ☐ Cracked ☐ Root Intrusion ☐ Deteriorated ☐ Leaks ☒ **Debris**

Channel Debris

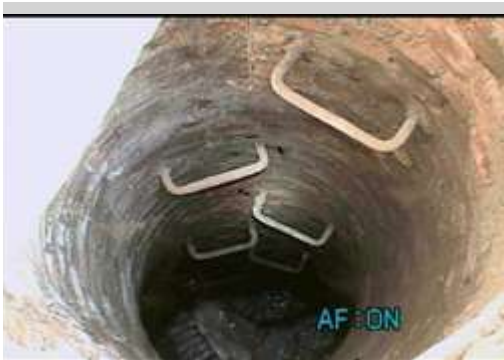
Defect 1

Count: **7** Missing: **0** ☒ **Corroded**

corroded steps

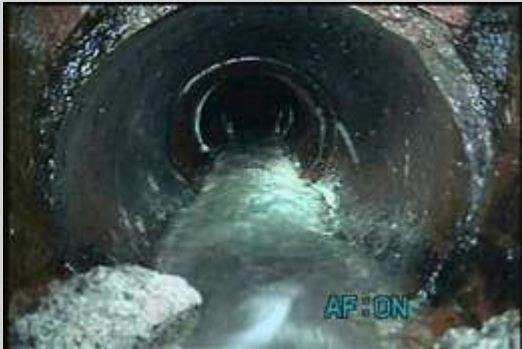
12 O'Clock Outflow

12 in. Circular Gravity Sewer  
Pipe Out @ 12 O'Clock

Pipe Material: **Clay** ☐ Pipe Lined

Invert Depth: **13.30** (ft.) Flow Characteristics: **Fast**

Infiltration: **None** Pipe Seal Cond: **Unknown**

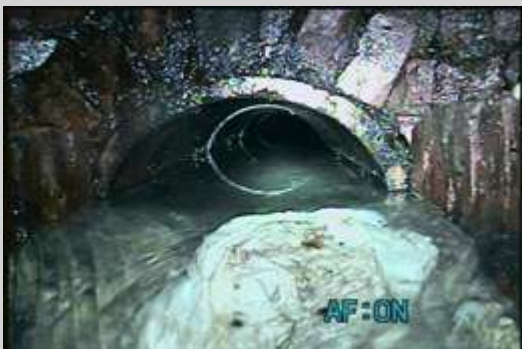
6 O'Clock Inflow

12 in. Circular Gravity Sewer  
Pipe In @ 6 O'Clock

Pipe Material: **Clay** ☐ Pipe Lined

Invert Depth: **13.10** (ft.) Flow Characteristics: **Fast**

Infiltration: **None** Pipe Seal Cond: **Unknown**

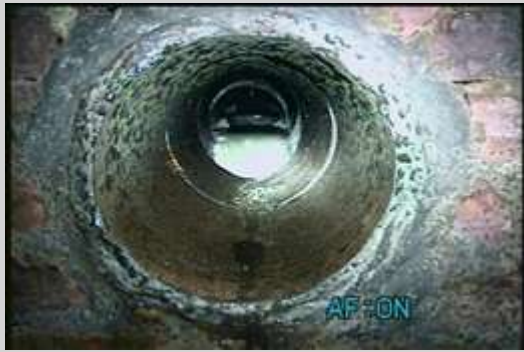
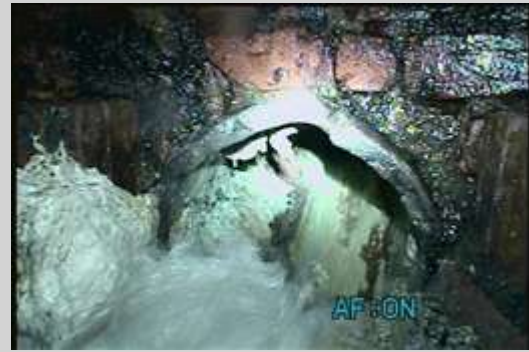
9 O'Clock Inflow

8 in. Circular Gravity Sewer

Drop In @ 9 O'Clock

Drop: **Outside** **Direct**

Drop Condition: **Open**
